Inspection Fields Notes/ Inspection Report

Date: September 13, 2012

Subject: City of Bangor MS4 Inspection

MS4 Compliance Sampling Inspection
City of Bangor, Maine

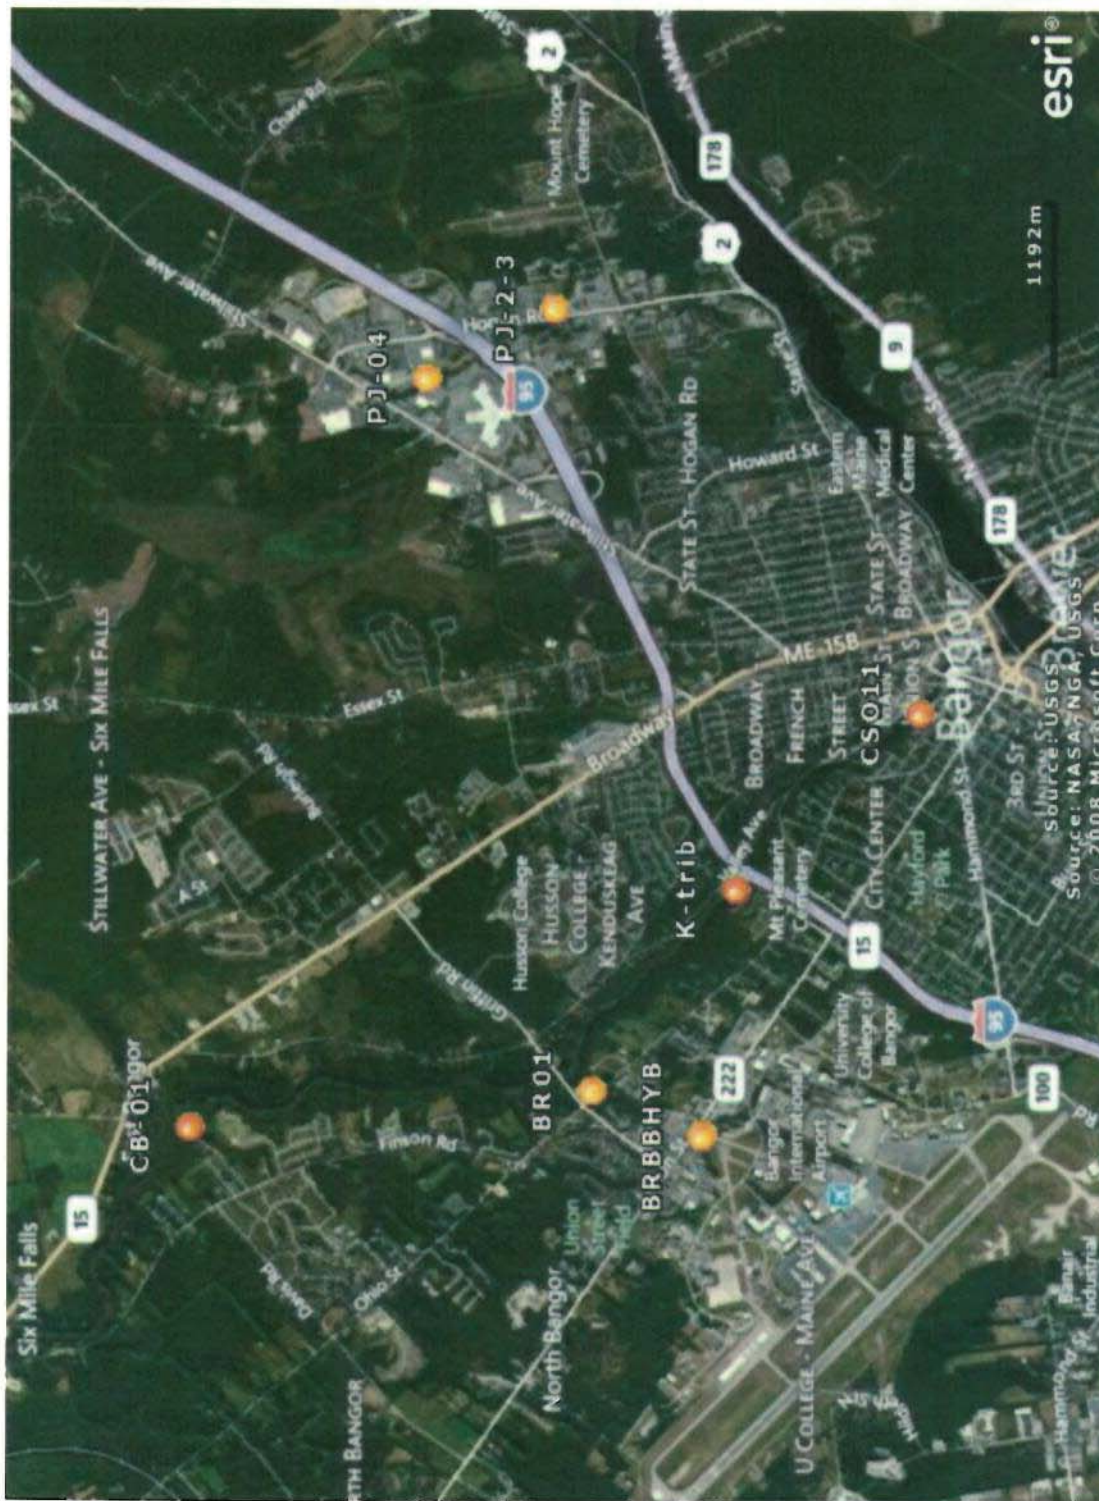
View of sampling locations collected July 8, 2013 and July 9, 2013. Note: Red symbols indicate approximate locations, orange symbols indicate GPS coordinates collected in field.

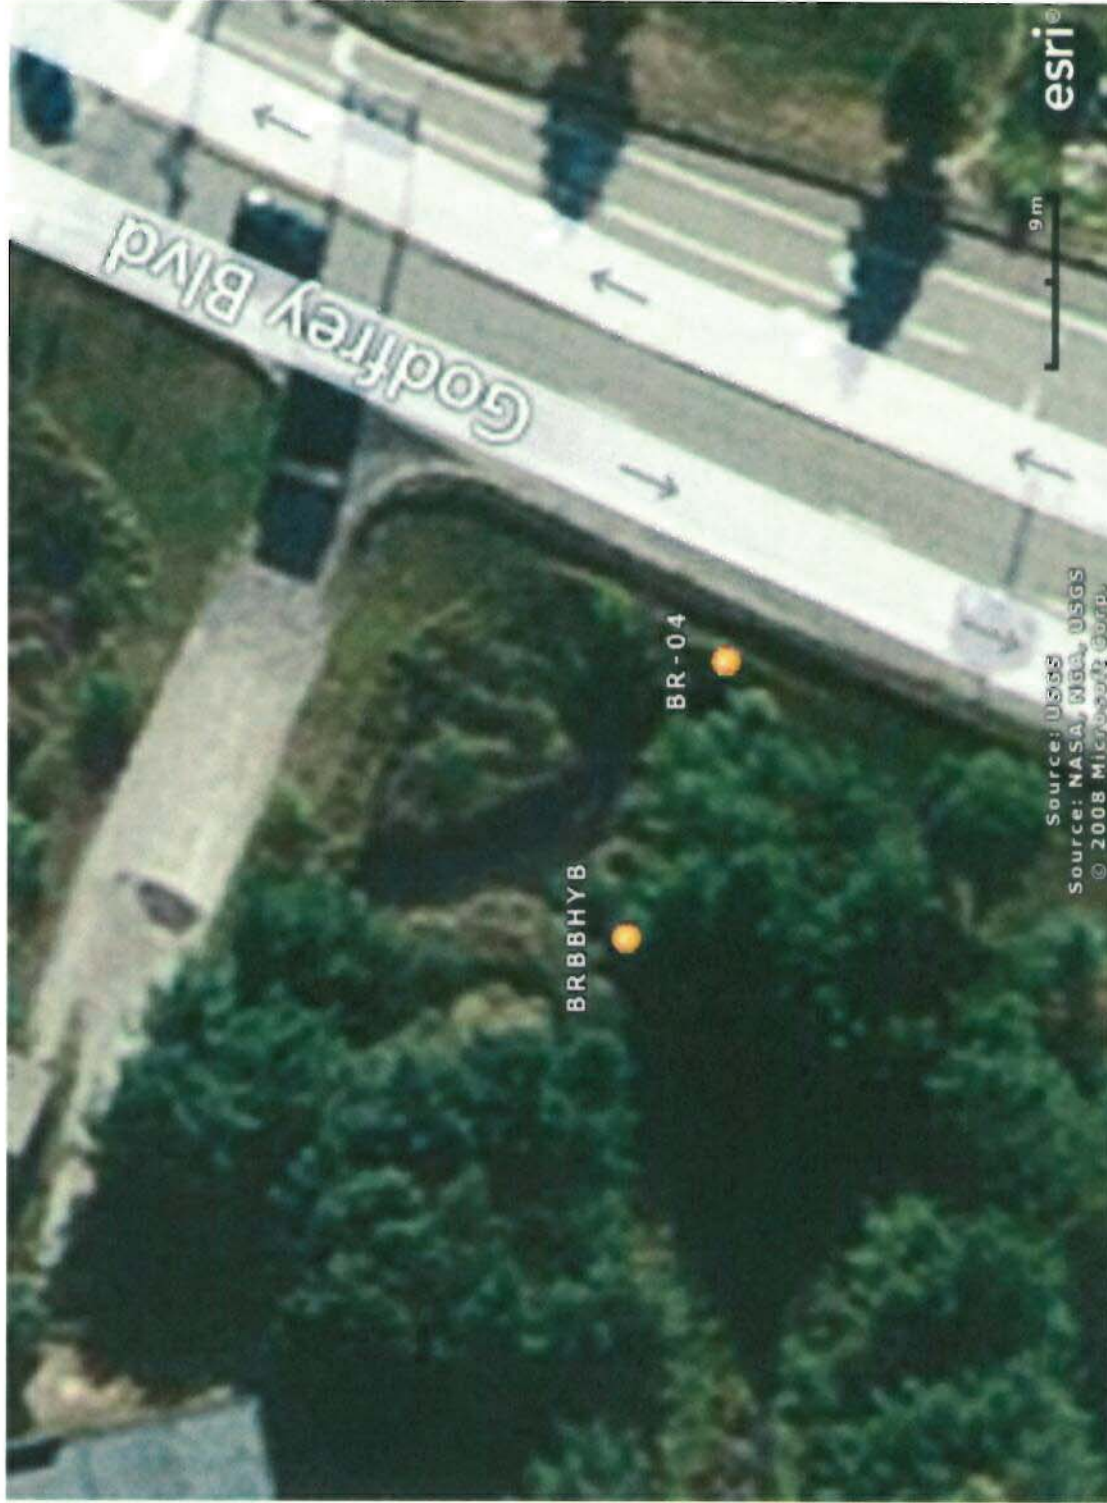
Close up view of sampling locations BRBBHYB and BR-04 collected July 8, 2013.

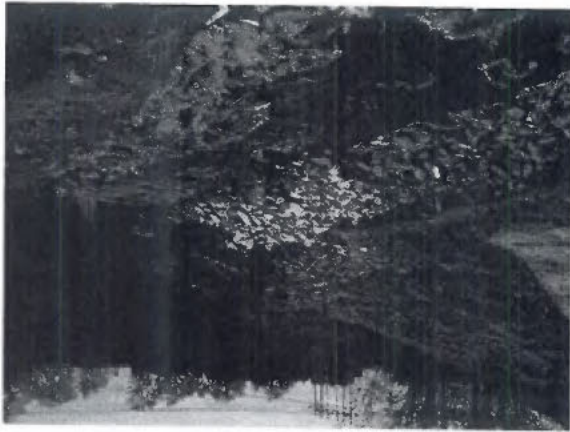
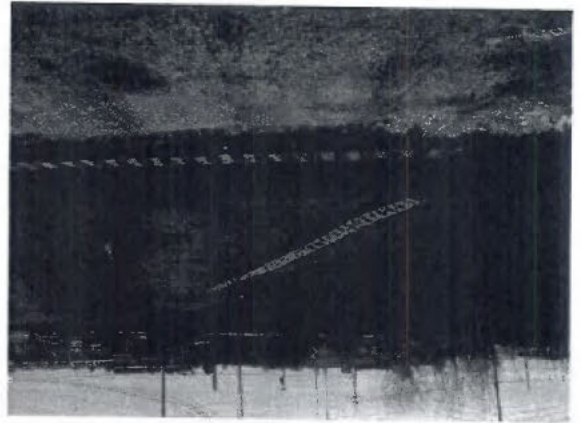
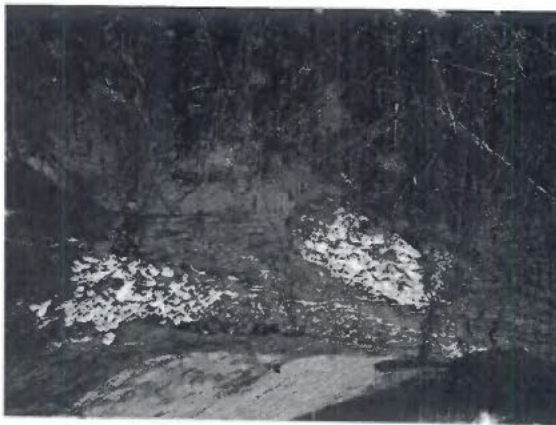
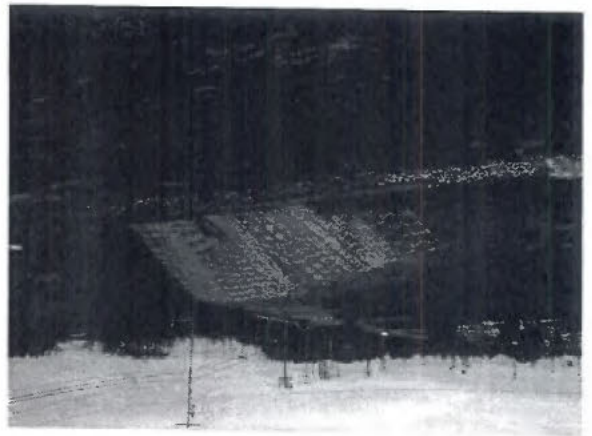
Additional winter stabilization was put in place.

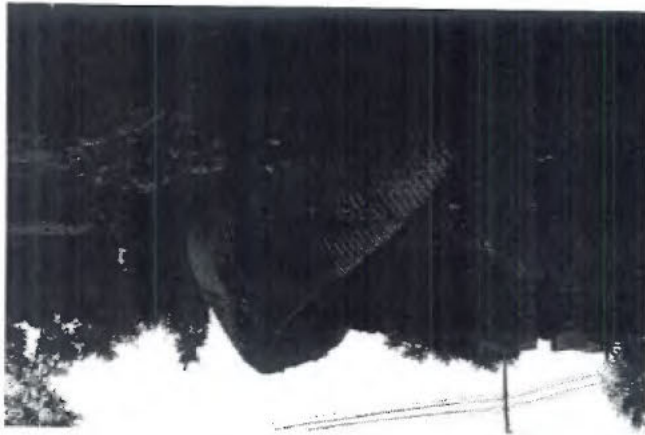
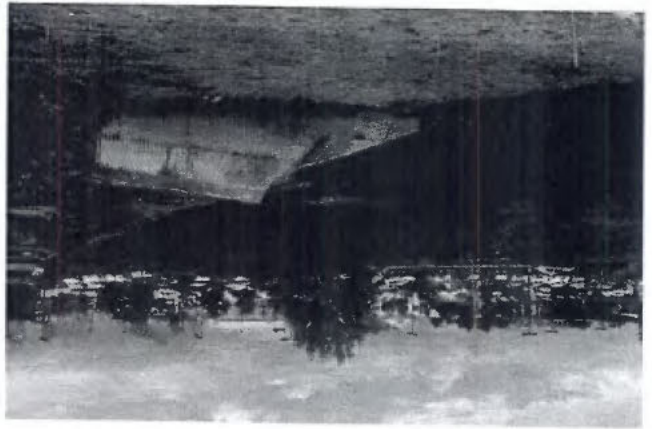
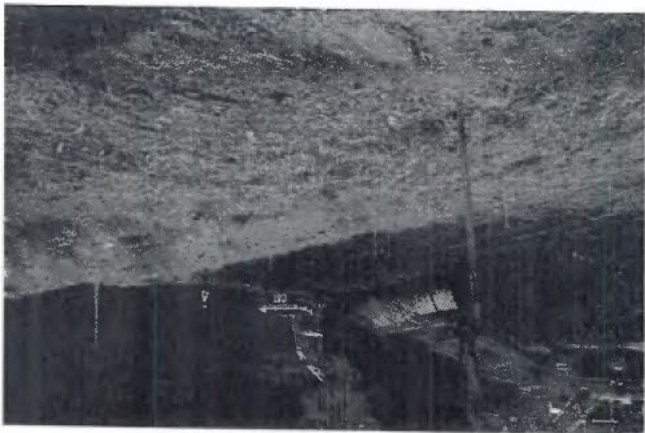
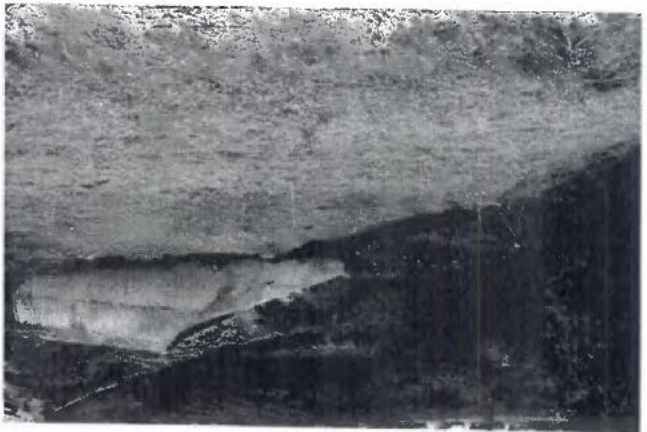
Photos Taken _____ Yes 2588-2593 _____ Prior to event

event. DEP also inspected site before and during event and was pleased with ESC measures. (Email attached.)

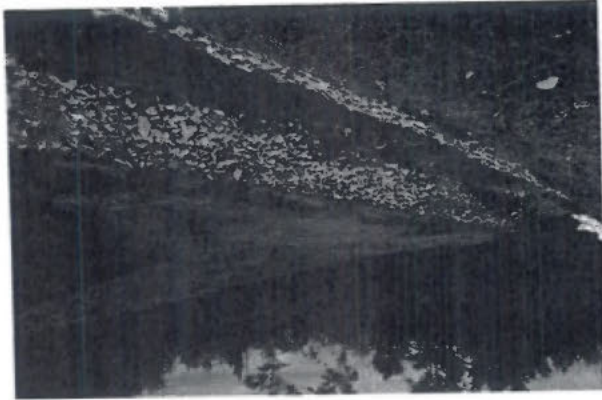
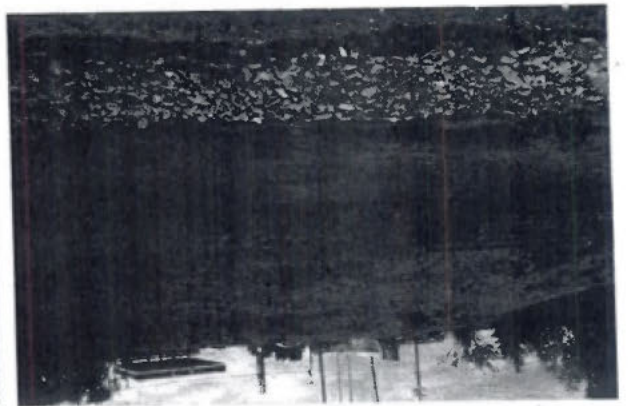
Photos Taken Yes 2623-2626

If yes, state corrective action & date completed. Checked site on Saturday 9/29/12 during event and on 10/11/12 after rain showers which began Friday p.m. and ended Sunday late evening. Site was stable during and after rain event. Debris was observed appx. 2/3 of the way up the protection stone, which also remained in place.

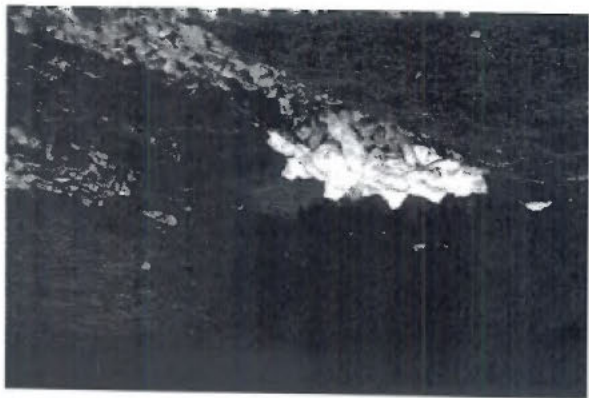
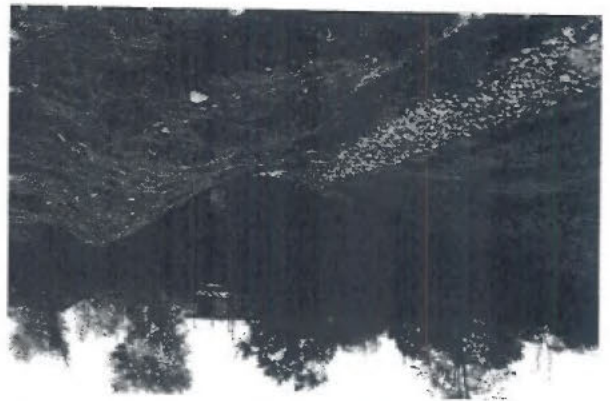
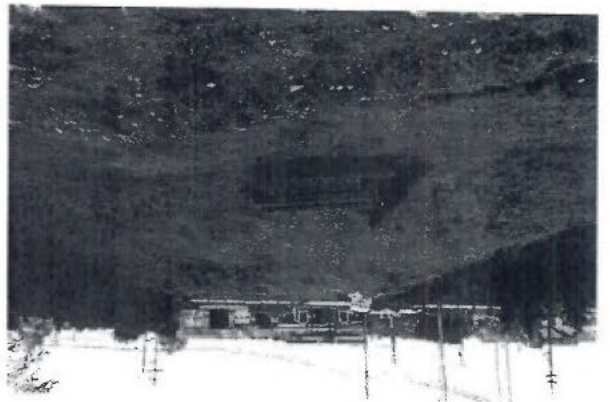
Photos Taken Yes 2678-2683

If yes, state corrective action & date completed: Mulching was still all in place following earlier rain event this week. Showers occurred on 10/4, showers are forecasted for upcoming weekend.

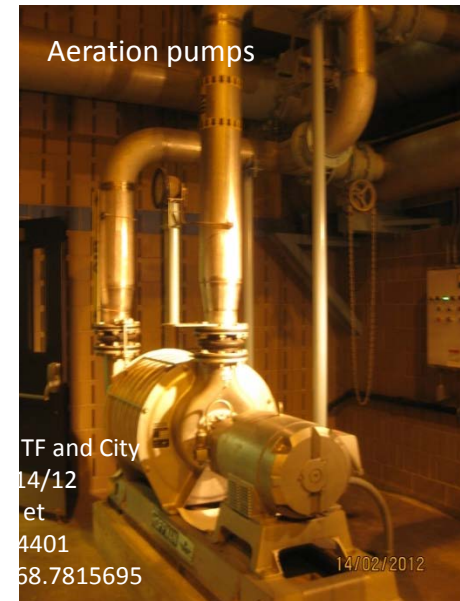
Aeration pumps

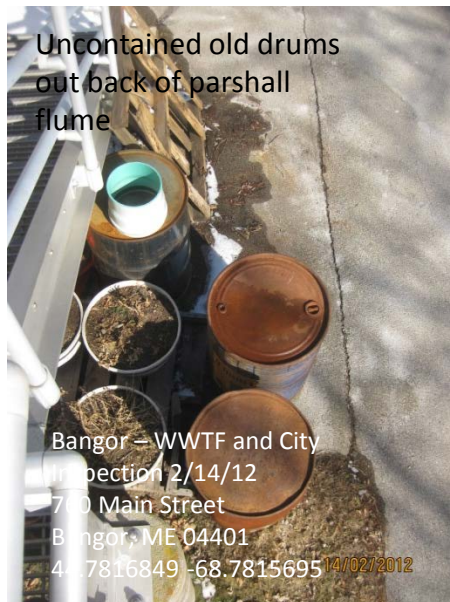
Uncontained old drums
out back of parshall
flume
